## TECHNICAL SERVICE BULLETIN

TSB 2016-1002 Level: 2

| Topic | Overtightening of 4-in-1 Ball Valve Tool (Core Removal Tool) can lead to failure and potential venting of the system under service. |

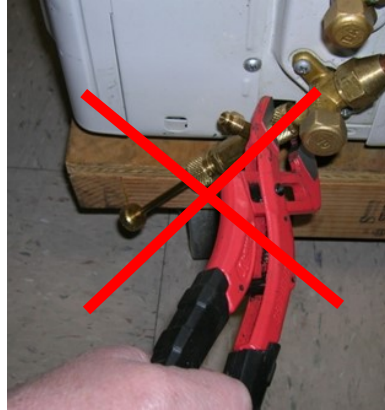
**Figure 4**

In testing, it was determined that over-tightening this tool during installation can cause failure resulting in the potential venting of the system under service.

1. TIGHTEN WITH ANY TOOL  
(Figure 4)
